RAILROAD ACCIDENT REPORT

**DERAILMENT OF LOUISVILLE &
NASHVILLE RAILROAD COMPANY'S
TRAIN NO. 584 AND
SUBSEQUENT RUPTURE OF TANK CAR
CONTAINING LIQUEFIED PETROLEUM GAS
WAVERLY, TENNESSEE
FEBRUARY 22, 1978**

1. Report No. NTSB-RAR-79-1		2. Government Accession No		3. Recipient's Catalog No	
4. Title and Subtitle Railroad Accident Report, -- Derailment of Louisville & Nashville Railroad Company's Train No. 584 and Subsequent Rupture of Tank Car Con- taining Liquefied Petroleum Gas, Waverly, Tennessee, February 22, 1978.				5. Report Date February 8, 1979

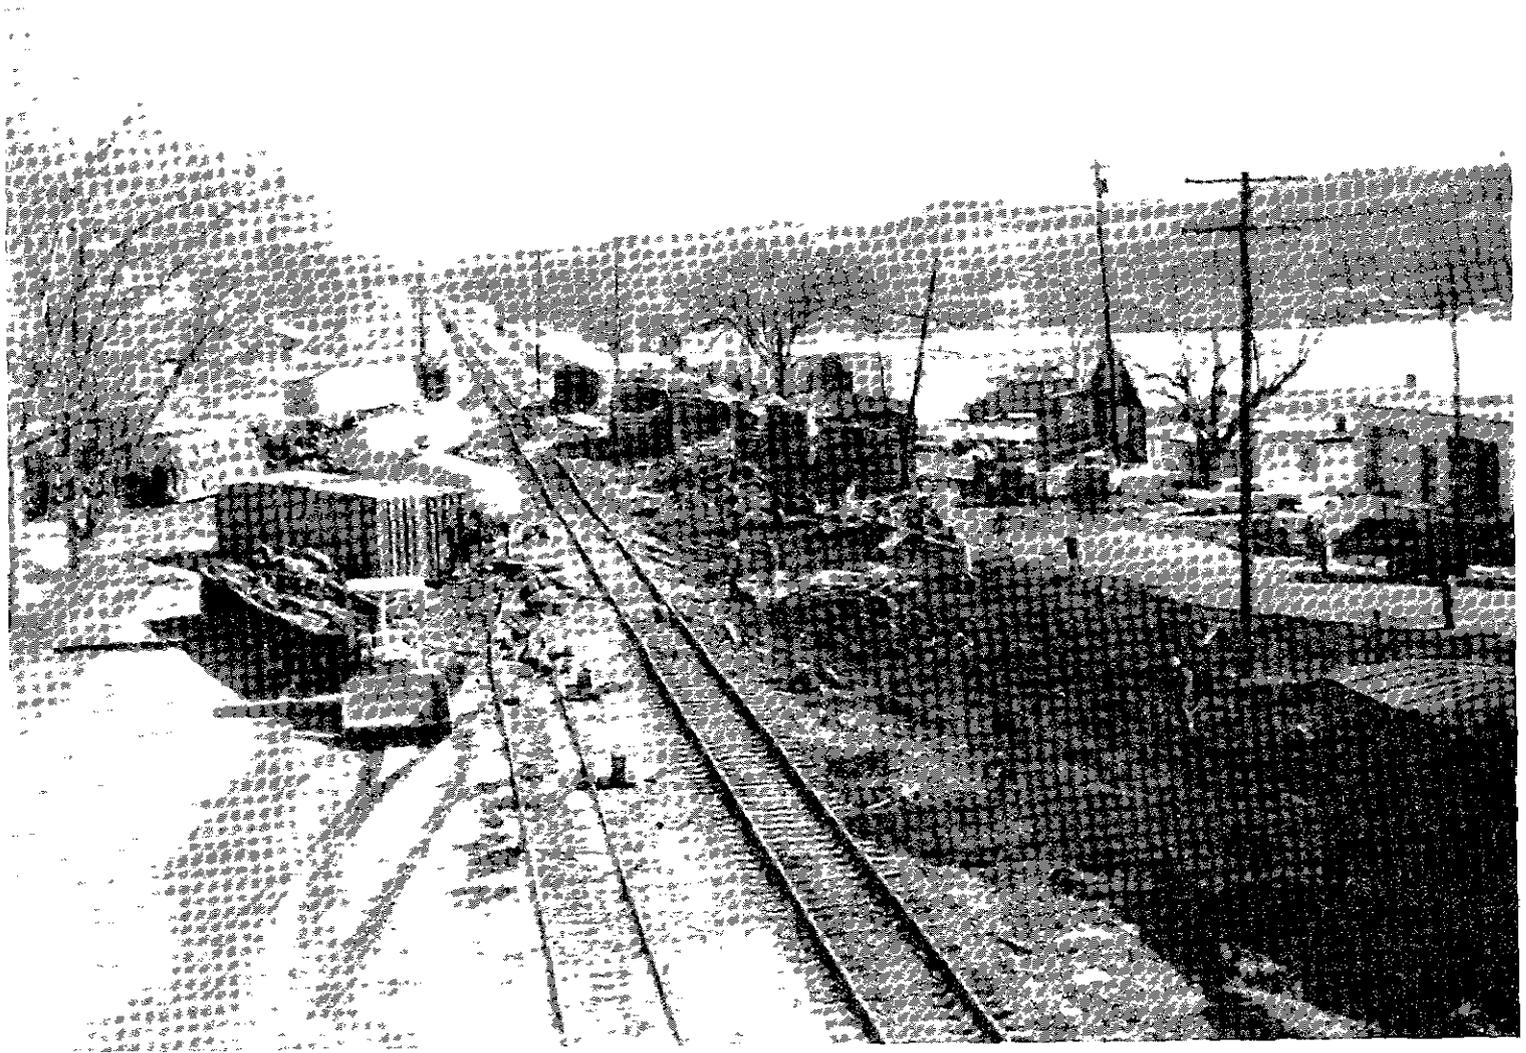
Figure 1. Location of tank cars immediately before rupture.

The L&N's wrecking crew continued to remove the derailed cars, and the main track was opened to rail traffic by 8:00 p.m., February 23. Tank trucks were ordered to unload the LPG from the relocated tank on the south end, since that car appeared to be the most severely damaged. An empty tank car was ordered so that the second tank could be unloaded on Friday morning, February 24. (See figure 1.)

A semitrailer/tank motortruck arrived at Waverly about 1:00 p.m. on February 24. A supervisor from the truck firm, who was familiar with handling LPG, and the truckdriver were on site but had not started the transfer, when about 2:53 p.m. UTLX 83013, the northernmost tank car, ruptured and allowed LPG to enter the atmosphere. Seconds later, the cloud of vaporized LPG was ignited by an undetermined source and burned explosively.

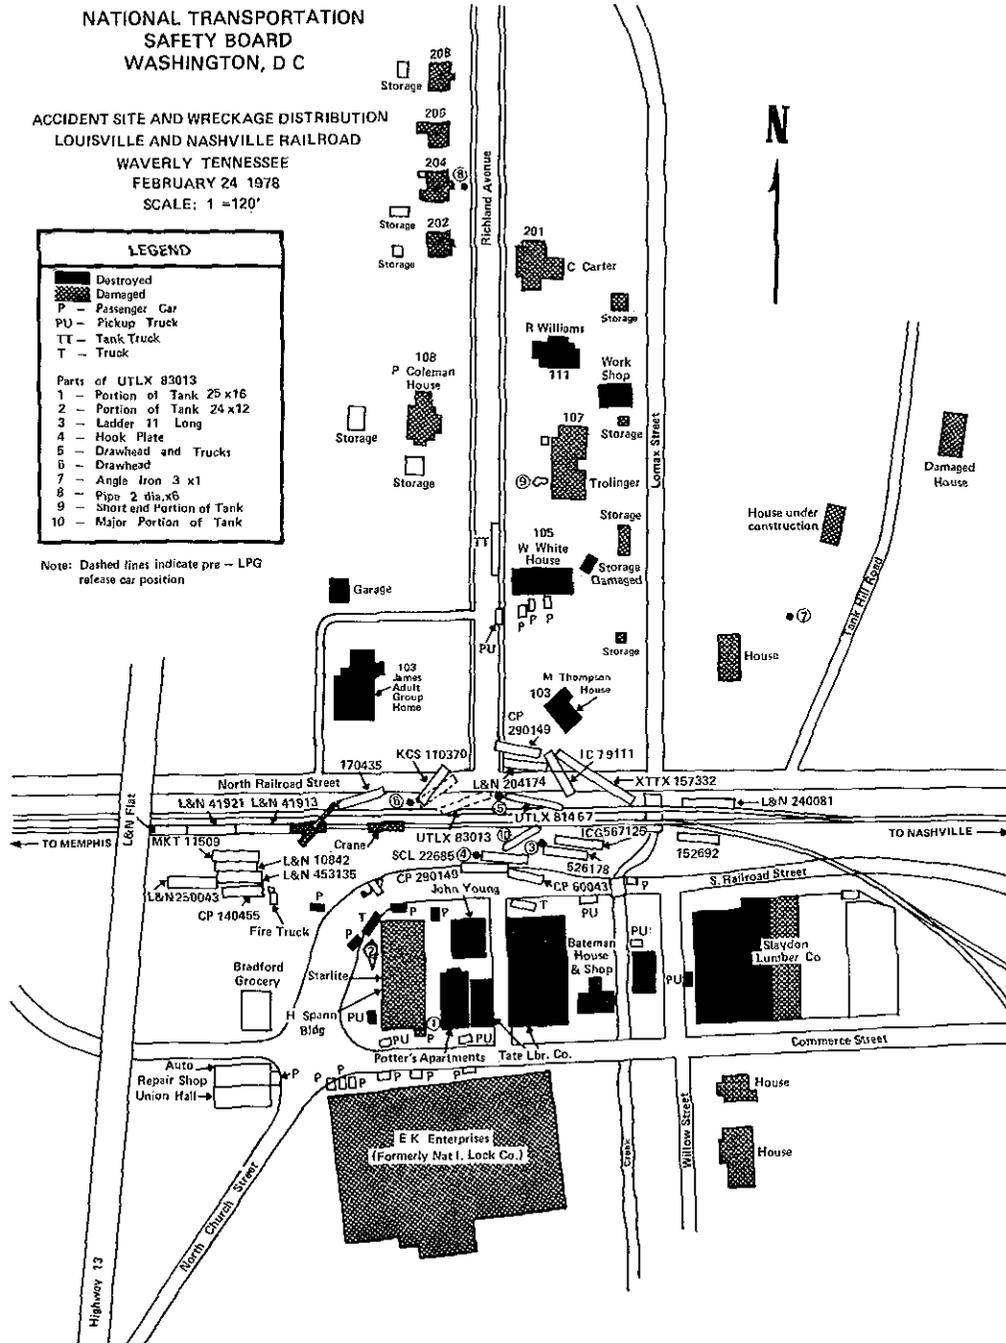
Figure 2. Plan view of accident site and wreckage distribution.

Of the 23 cars derailed in Train No. 584 and 4 cars that were standing on the siding at Waverly, a total of 15 cars were destroyed and 12 others sustained damages ranging from slight to severe. In addition, about 400 feet of track was destroyed.

The fire resulting from the ruptured tank destroyed 18 buildings and 26 motor vehicles within the city of Waverly. The damaged structures included both commercial and residential buildings. (See figure 2.)

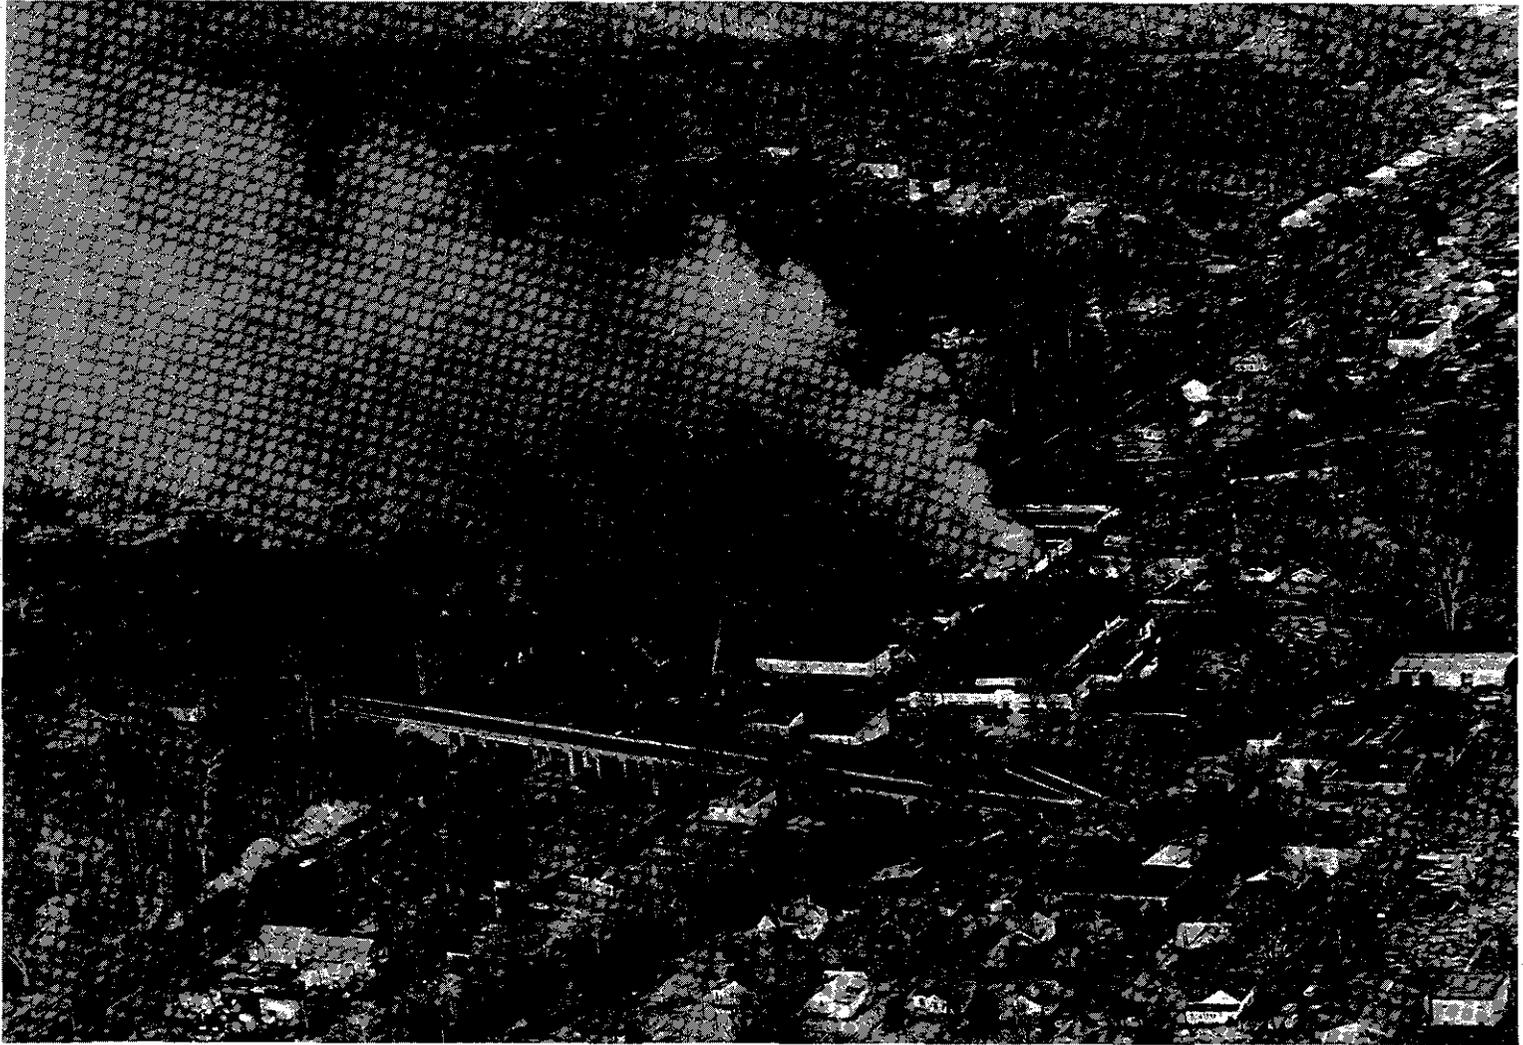
Figure 3. Accident site following the tank car rupture.

The rupture and resultant fires disabled the majority of on-scene Waverly Fire Department personnel and rendered hoses and other fire-fighting equipment useless. Fires burned close to the second and still intact tank car of LPG. Several fire engines from nearby communities were brought to the scene within an hour of the rupture and primary

efforts were focused on preventing the second tank from exploding. By 3:45 p.m., deluge guns poured water onto the tank cars. By 5:00 p.m., all fires in the vicinity of the tank were extinguished and at 7:00 p.m., all significant fires in the area were under control. Sixty-four fire units with over 200 firemen were on site by 9:00 p.m. All personnel and 11 pieces of fire equipment remained on site until the second tank car of LPG was unloaded. (See figure 3.)
